BREAKWATER LOCATION
U. S. NAVAL AIR STATION, ALAMEDA, CALIFORNIA

MODEL INVESTIGATION

TECHNICAL MEMORANDUM NO. 2-242

DECEMBER 1947

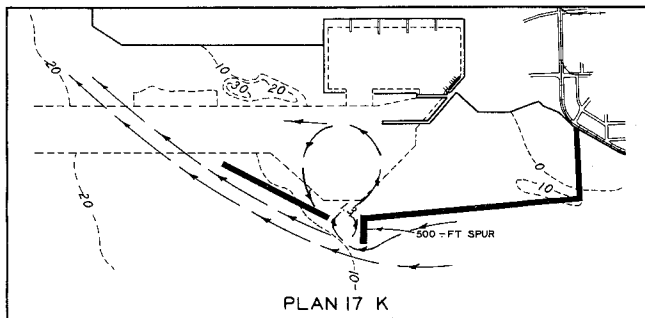
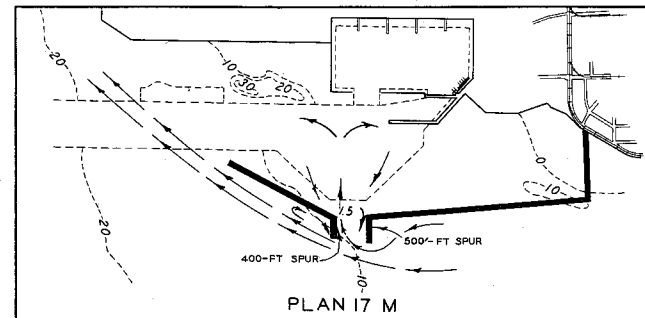
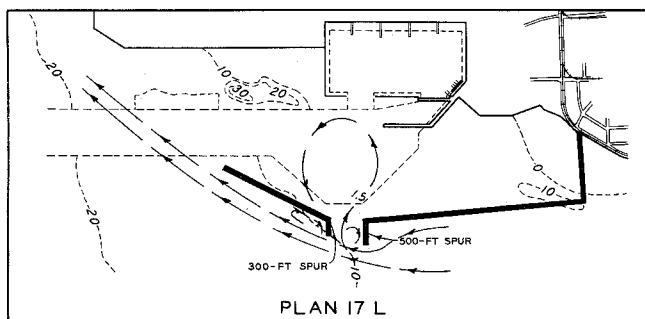
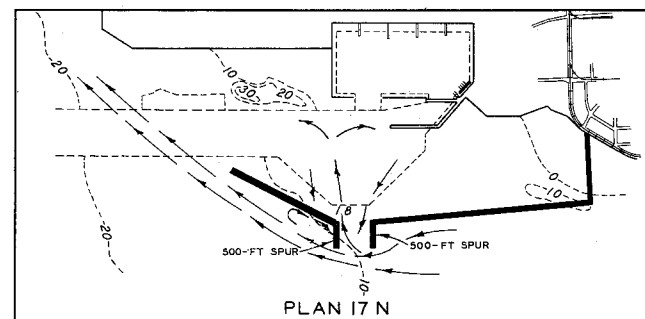
- BREAKWATER LOCATIONS
- EBB TIDE CURRENT - FEET
PER SECOND PROTOTYPE

NOTE: WIDTH OF NAVIGATION OPENING EQUALS 750 FT.
CURRENT DIRECTION AND MAGNITUDE MEASURED
WITHOUT WAVE ACTION.

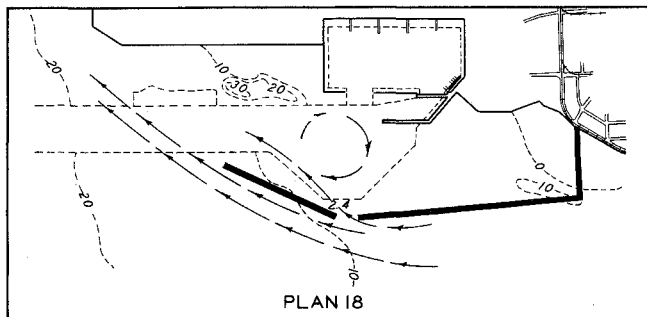
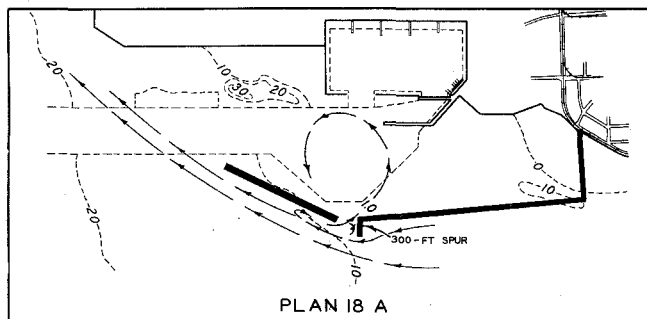
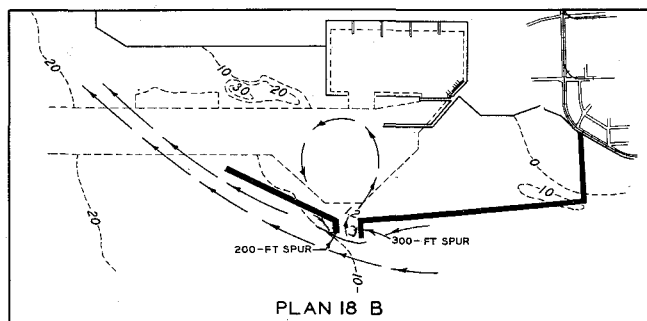
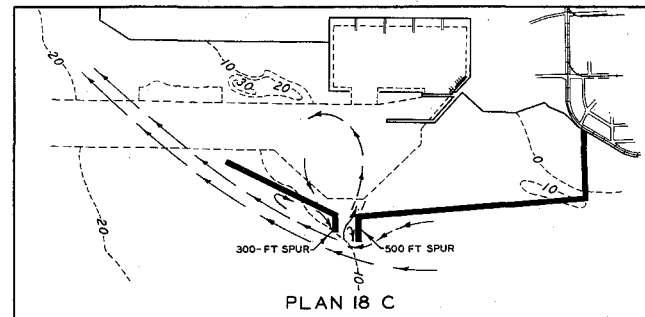
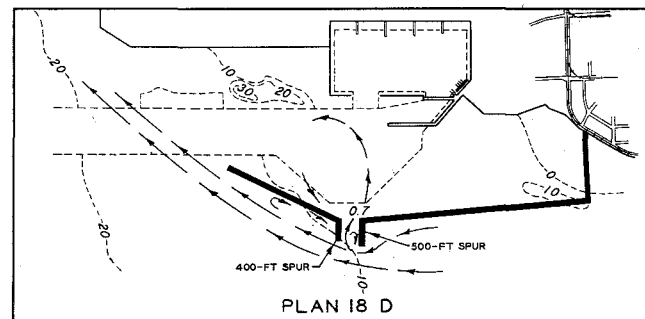
- BREAKWATER LOCATIONS
- 2.4 EBB TIDE CURRENT - FEET PER SECOND PROTOTYPE

NOTE: WIDTH OF NAVIGATION OPENING EQUALS 500 FT.
CURRENT DIRECTION AND MAGNITUDE MEASURED
WITHOUT WAVE ACTION.

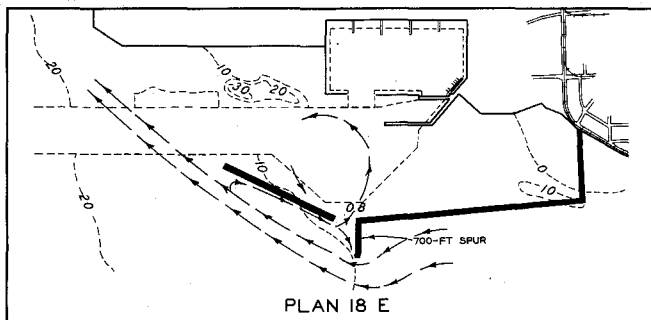
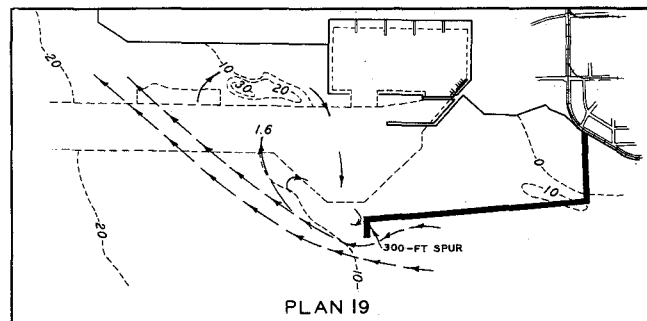
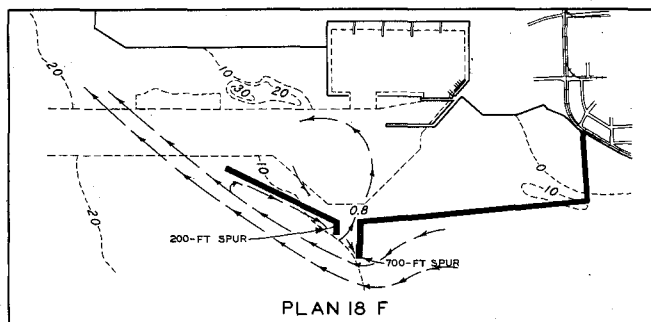
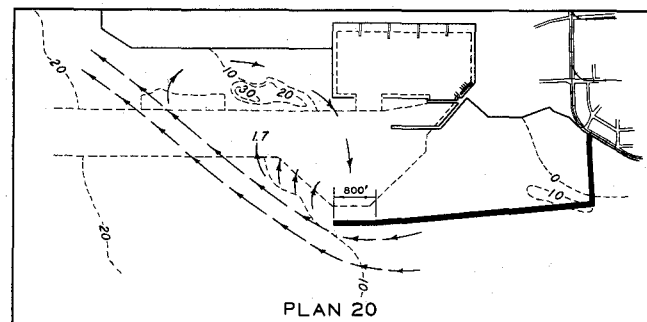
- BREAKWATER LOCATIONS
- ← 0.8 — EBB TIDE CURRENT — FEET
PER SECOND PROTOTYPE

NOTE: WIDTH OF NAVIGATION OPENING EQUALS 500 FT.
CURRENT DIRECTION AND MAGNITUDE MEASURED
WITHOUT WAVE ACTION.

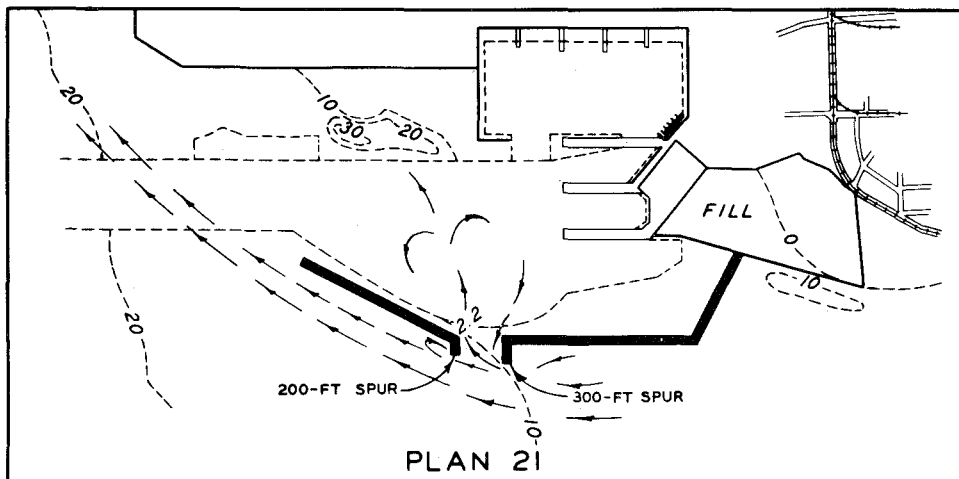
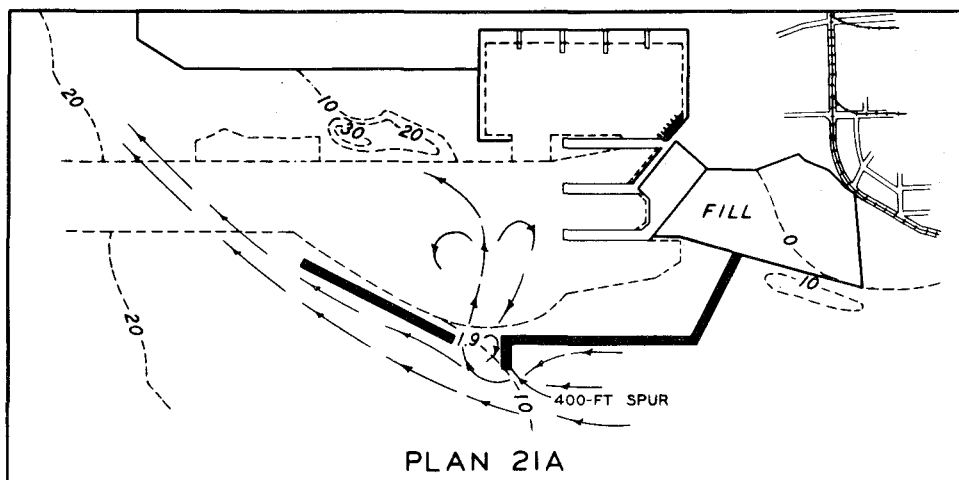
MAGNITUDE AND DIRECTION OF CURRENTS AT NAVIGATION OPENING

NOTE: WIDTH OF NAVIGATION OPENING EQUALS 750 FT.
CURRENT DIRECTION AND MAGNITUDE MEASURED
WITHOUT WAVE ACTION.
